RESEARCH MEMORANDUM

FLIGHT AND WIND-TUNNEL INVESTIGATION TO DETERMINE THE
AILERON-VIBRATION CHARACTERISTICS OF $\frac{1}{4}$ -SCALE WING
PANELS OF THE DOUGLAS D-558-2 RESEARCH AIRPLANE

Ellwyn E. Angle and Reginald R. Lundstrom

November 30, 1948
Declassified May 8, 1957

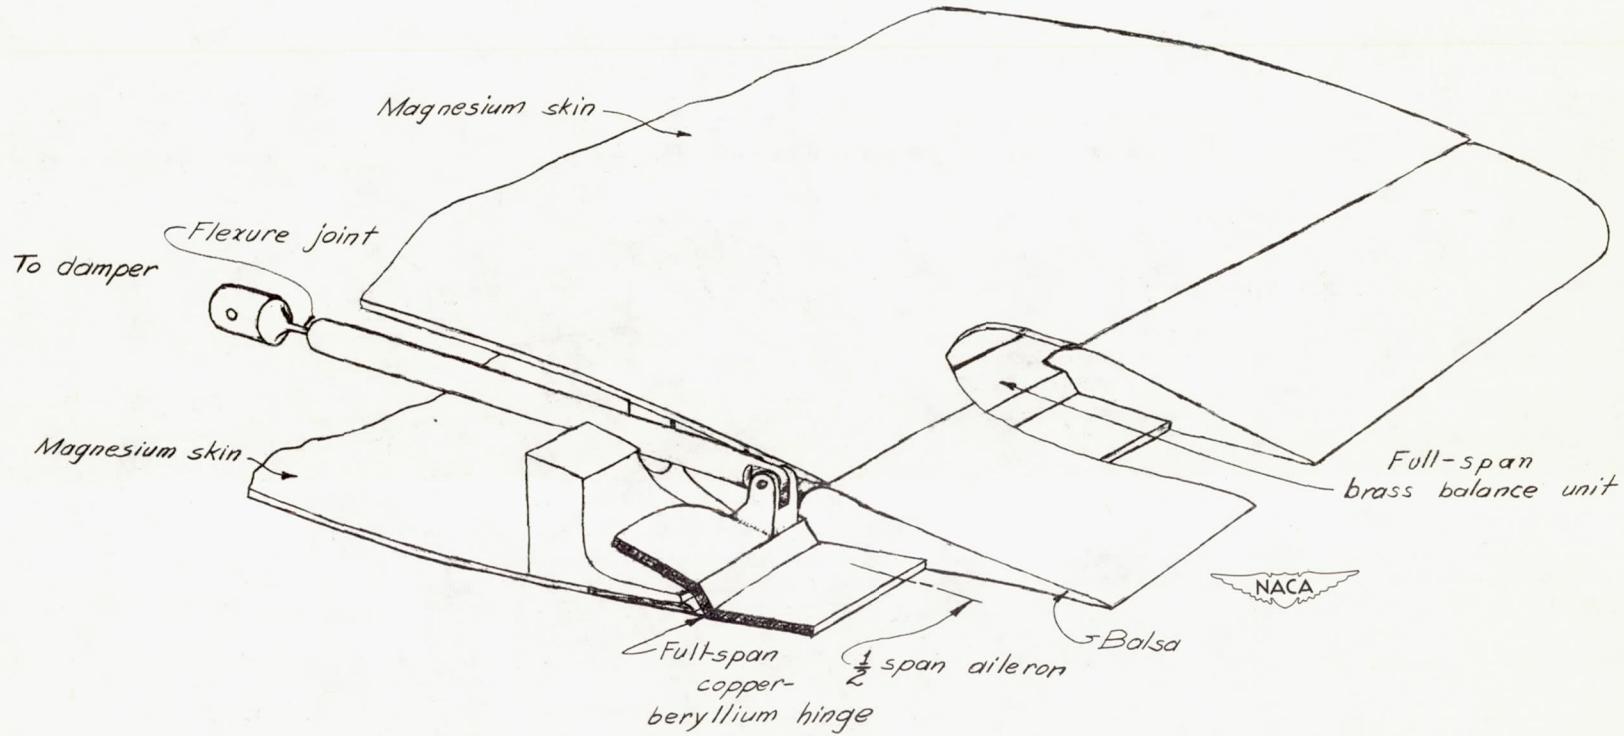
Figure 4.- Aileron details, $\frac{1}{4}$ -scale aileron "buzz" models of Douglas D-558-2 research airplane.

The change in floating angle of the ailerons occurs at approximately the same Mach number as the sharp drop in control effectiveness and increase in drag coefficient experienced by tests of this same wing. (See reference 2.) Calculations show that the critical Mach number of the wing is about 0.94. All these factors indicate that the Mach number was greater than the critical Mach number throughout the range of the high-frequency vibration ($M = 0.96$ to highest attained $M = 1.01$). Because the third type of vibration is different from the other two and because it occurs at a Mach number above the critical Mach number of the wing, it is possible that this vibration is aileron buzz. Although the aileron is statically mass-balanced at zero deflection, it is not mass-balanced when deflected because it is hinged to the lower surface of the wing. (See fig. 4.) This might be a contributing factor toward development of the vibration obtained.

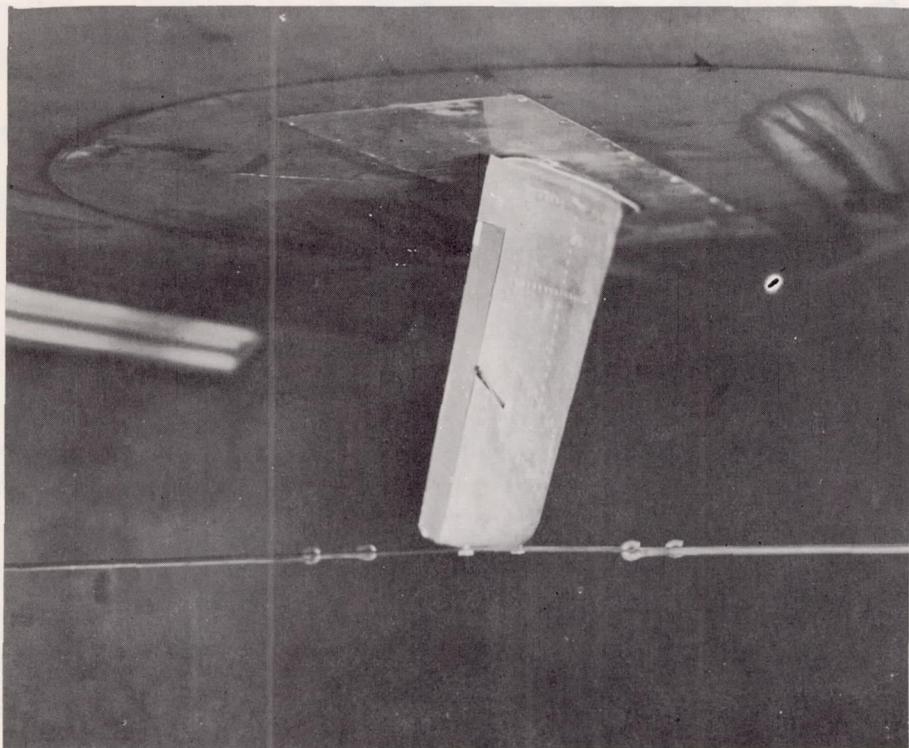
Figure 7.- Test wing-aileron panel with tip restraints mounted on tunnel wall.

The results of the wind-tunnel investigation are listed in table III. Large wing-tip deflections were observed along with the aileron vibration that occurred in the initial test ($M = 0.58$ to $M = 0.70$) and indicated the possibility of flexure-aileron flutter. The aileron hinge was cracked and screws holding the wing skin to the wing framework were found to be loose when the tunnel was shut down. This might account for the low-vibration frequency at a Mach number of 0.70.

The second run was made with the wing tip restrained, thereby increasing the rigidity of the wing so as to isolate possible aileron buzz. Strain gages were mounted inside the wing so that wing vibration would be noted. Tests were run with a damper adjusted for 0.083 foot-pounds per radian per second and also with a dummy damper. No vibrations occurred in either test up to a Mach number of 0.85 which was the maximum that could be attained.

With the restraints removed and the damper adjusted to give 0.016 foot-pounds per radian per second, a vibration developed similar to the first run but at a higher Mach number and a smaller amplitude. The aileron hinge again failed and the aileron was destroyed.

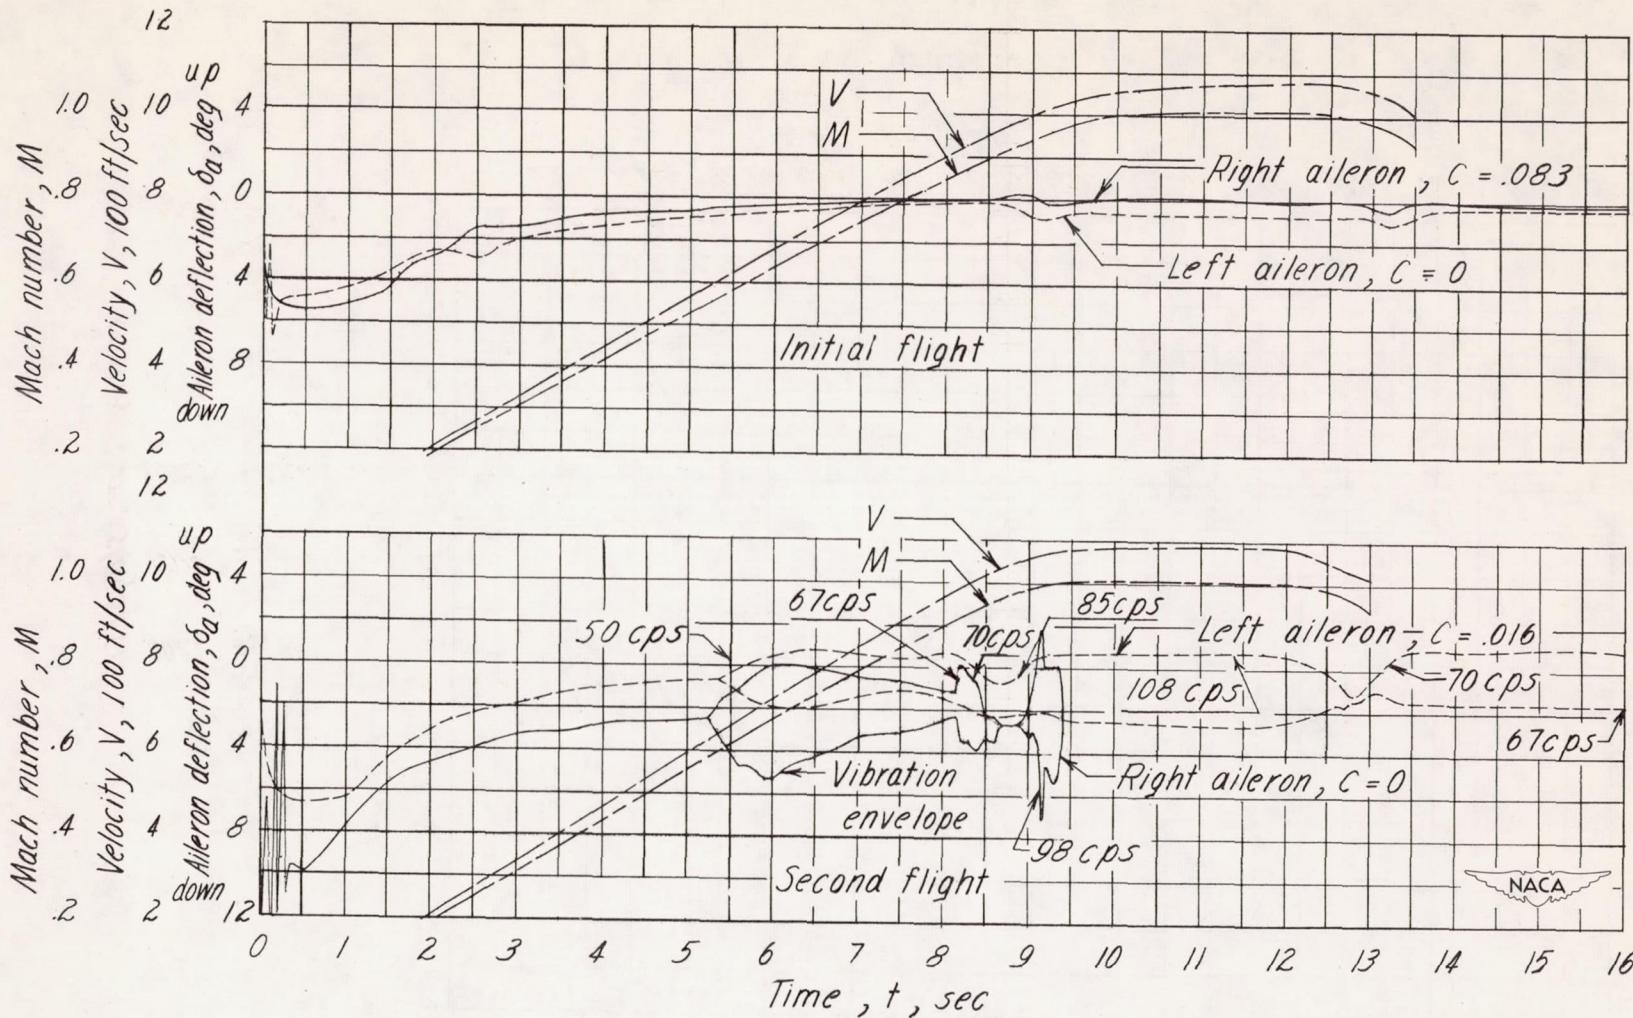
Figure 8.- Results of flight test of $\frac{1}{4}$ -scale aileron "buzz" models.

The aileron of the left wing in the initial free-flight test was undamped except for the friction of the dummy damper, and the damper of the right aileron was equipped with the proper orifice plug to give $C = 0.083$ foot-pounds per radian per second. It can be seen from the upper set of curves in figure 8 that no vibration of the aileron occurred up to a Mach number of 1.03, which was the maximum attained in the test.

Since no aileron buzz developed, the test was repeated to confirm the results of the first test. The second test was conducted with a dummy damper attached to the right aileron and a damper adjusted to give 0.016 foot-pounds per radian per second on the left aileron. During the flight a vibration of 50 cycles per second developed on the right aileron at a Mach number of 0.58 and continued to a Mach number of 0.73. Between a Mach number of 0.73 and a Mach number of 0.9 a 67-cycle-per-second vibration gradually became superimposed upon this 50-cycle-per-second vibration, becoming a pure 67-cycle-per-second vibration at a Mach number of 0.9. This gradually increased in frequency to 70 cycles per second at a Mach number of 0.96. Between 9.1 seconds ($M = 0.99$) and 9.4 seconds ($M = 1.00$) the right aileron trace shows a violent oscillation that ends abruptly at 9.4 seconds as shown in the lower curves of figure 8. Inspection of the deflection signal on the telemeter record after 9.4 seconds indicates the possibility of either a structural failure of the aileron or a failure of the control-position indicator. The left aileron developed a vibration at $M = 0.59$ having the same frequency variation as the right aileron with increase in speed. After the floating angle changed ($M = 0.96$), the frequency changed to 85 cycles per second and gradually increased to 108 cycles per second at a Mach number of 1.01 (Reynolds number is 10,500,000). During the decelerated flight the frequency again gradually decreased to 85 cycles per second until the floating angle again changed at a Mach number of 0.96. The vibration momentarily ceased as the floating angle changed and started again at 70 cycles per second, gradually decreasing to 67 cycles per second. At a Mach number of approximately 0.73, this vibration momentarily ceased and a 50-cycle-per-second vibration started and continued for the remainder of the flight.

As may be seen in figure 8, the amplitude of the aileron vibrations during the low-speed phase ($M = 0.58$ to $M = 0.73$) and the high-speed phase ($M = 0.96$ to $M = 1.01$) increased with increasing Mach number. The amplitude of the second-phase vibration during decelerating flight was approximately constant, but during accelerated flight this phase was of such short duration and so near the floating-angle change that no amplitude variation could be determined.

Figure 8 also gives an indication of the effect of damping on the amplitude of the vibration. During the low-speed phase, which wind-tunnel tests showed to be flexure aileron flutter, the vibration amplitude of the undamped aileron was about twice that of the damped aileron. The data that were obtained from the undamped aileron during the high-speed phase ($M = 0.96$ to $M = 1.01$) indicate that the amplitude was approximately twice that of the damped aileron.
